# **San Joaquin Valley Drainage Authority**

## **San Joaquin River Up-Stream DO TMDL Project ERP - 02D - P63**

### **Task 4: Monitoring Study**

#### **Final Task Report May, 2008**

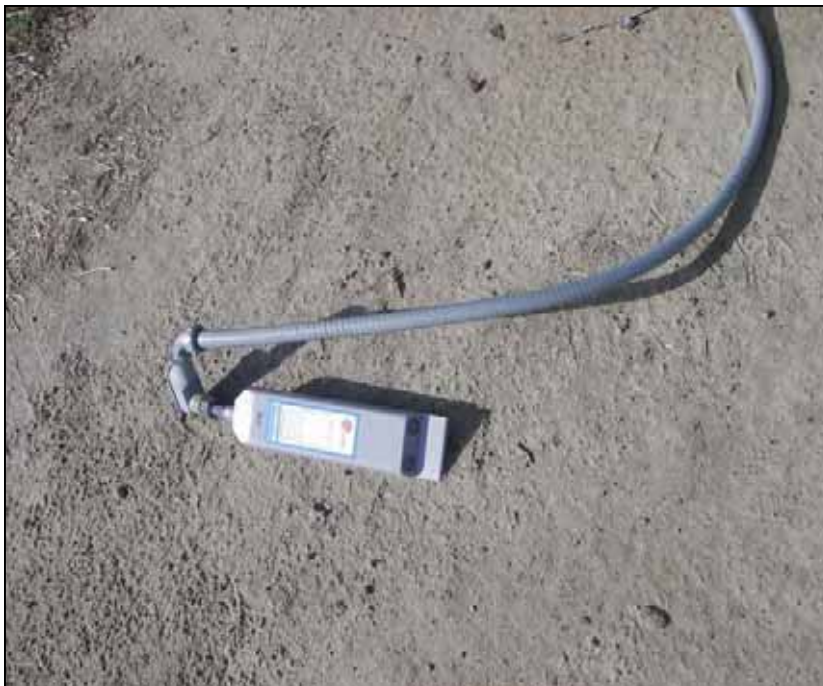
**Starflow Doppler flow meter**  
Picture of Sontek Doppler flow meter with protective tubing around cord. The Starflow is put on the bottom of the channel to measure flow.

Returned to DO-35 Westley Wasteway Flow station to re-install DA logger after ensuring it was functioning properly with equipment at UOP. Found that the cable to the Starflow Doppler flow meter had been sliced open while a backhoe was clearing debris from the channel. Determined that the destroyed Starflow Doppler flow meter was causing a short circuit and making the logger freeze every time it tried to take a measurement. Disconnecting the cable solved the problem.

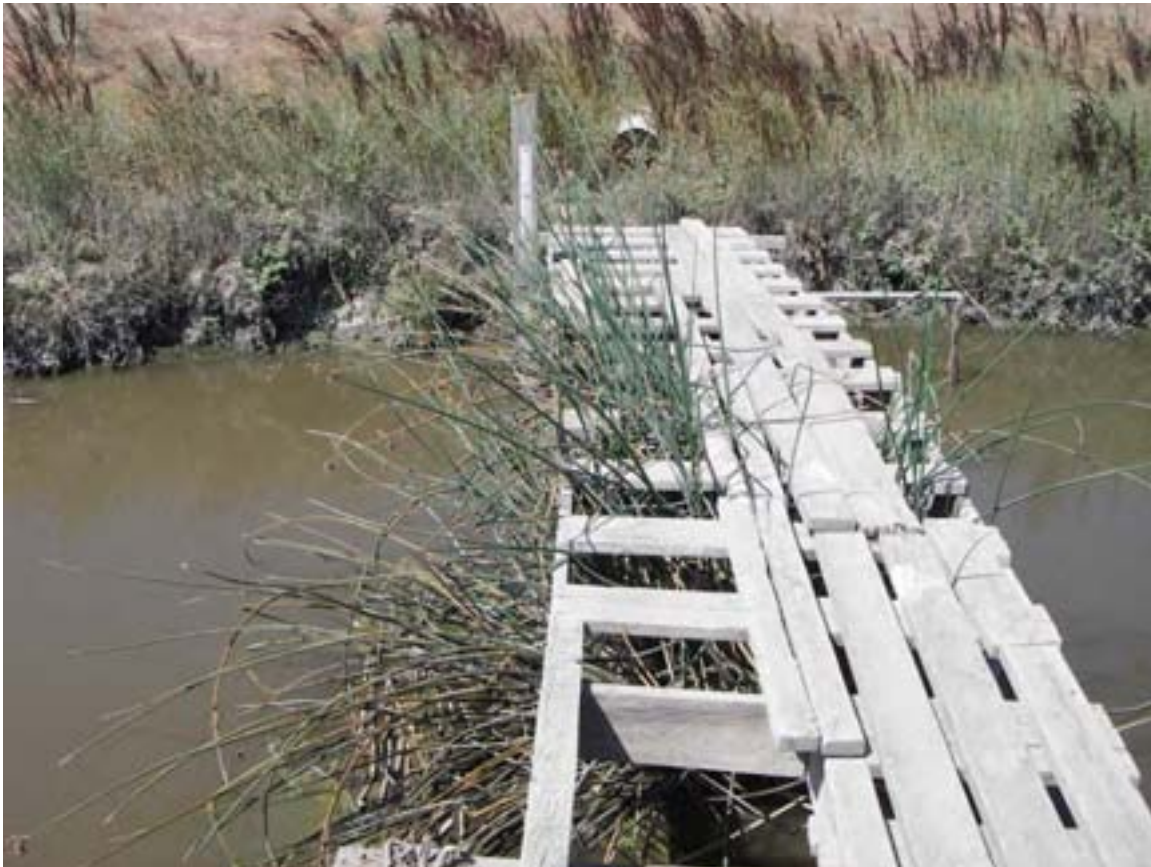
**Figure 2: New bridge and equipment installed at Los Banos Creek after old bridge was washed out.**

Sometimes natural events, such as storms, washed out a station. On January 9<sup>th</sup>, 2006 the sensors and bridge at DO-20 Los Banos Creek Flow Station were found washed out. The bridge was replaced by Grasslands Water District in March 2006 and the bubbler installed September 5<sup>th</sup>, 2006 and the Sontek installed October 31<sup>st</sup>, 2006. On Feb 2<sup>nd</sup>, 2006 DO-45 Volta Wasteway at Ingomar Grade the staff gauge was remounted on a metal pole because the first (wood) fixture had rotted out. The station at DO-57 Ramona Lake was washed out in the 2006 April floods and was repaired in March 2007. Occasionally there were problems with the wiper that cleans the optic sensors on the sonde used for sampling and extended deployments causing the wiper to park over the sensor and present invalid readings. This happened on September 7<sup>th</sup>, 2006 to one of the crews on a Core sampling event. On October 26<sup>th</sup>, 2006 the sonde used for sampling had the DO sensor membrane punctured and had to be replaced in the field.

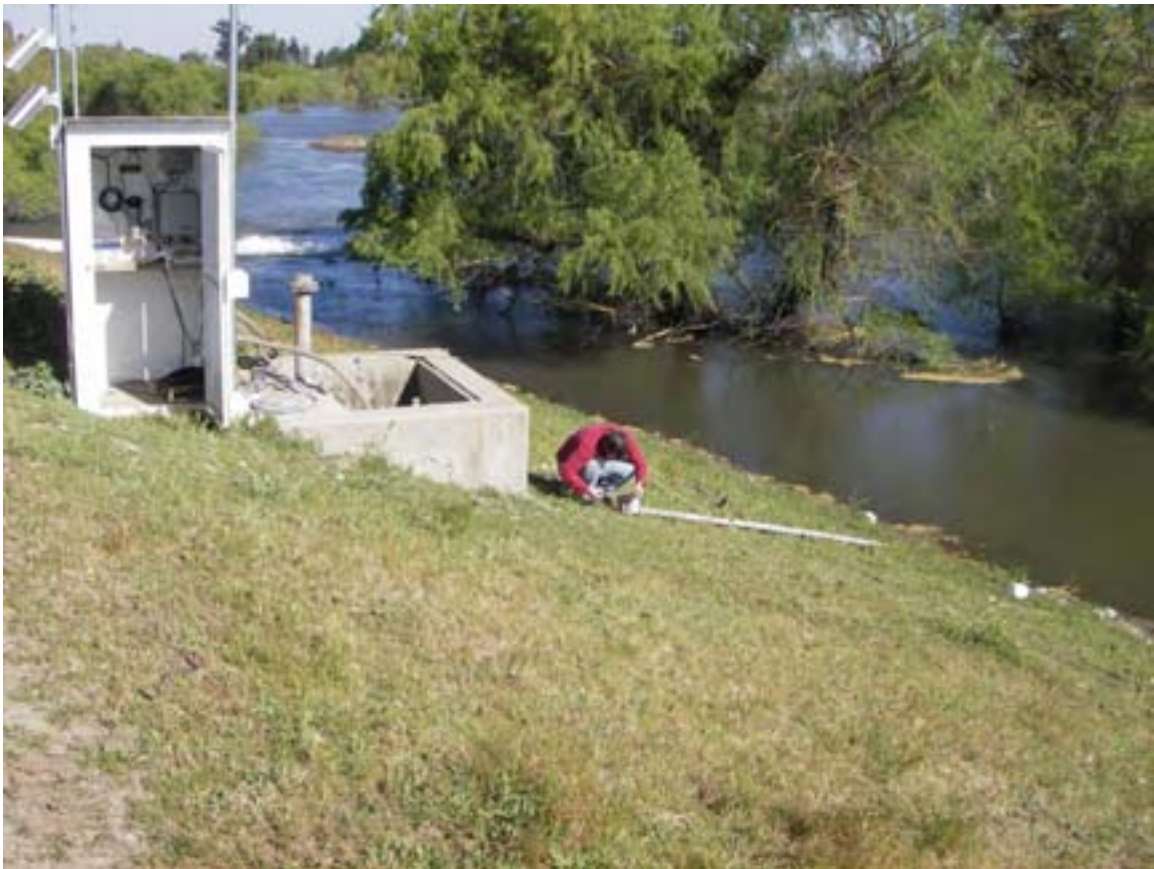
**Figure 10: Ramona Lake Drain flow station shed and manhole after repairing the damage from San Joaquin River flooding during 2005/2006.**

The majority of continuous monitoring stations worked without major problems. Stations that were reliable in 2005 were reliable in 2006 and 2007 with the exception of DO-20 Los Banos Creek and DO-57 Ramona Lake which were washed out by spring floods in 2006 and not repaired until late 2006 and early 2007, and DO-36 Del Puerto Creek which had a clog in the bubbler line for the last half of 2007. DO-35 Westley Wasteway Flow Station was not reliable in 2005 (in part due to illegal dumping activities blocking structures) and this station was relocated and completely remodeled and upgraded in 2006. There were a number of Starflow related problems in 2005 and a few units had to be removed and brought to UOP to troubleshoot. The QA stage at DO-38 Marshall Road Drain and DO-65 Spanish Grant Drain was not reliable from September 9<sup>th</sup>, 2007 until the end of the year because of the sediment buildup in the bottom of the weir structure. Occasionally leaks were found in the bubbler lines, but these were due to loose connections that were easily fixed.

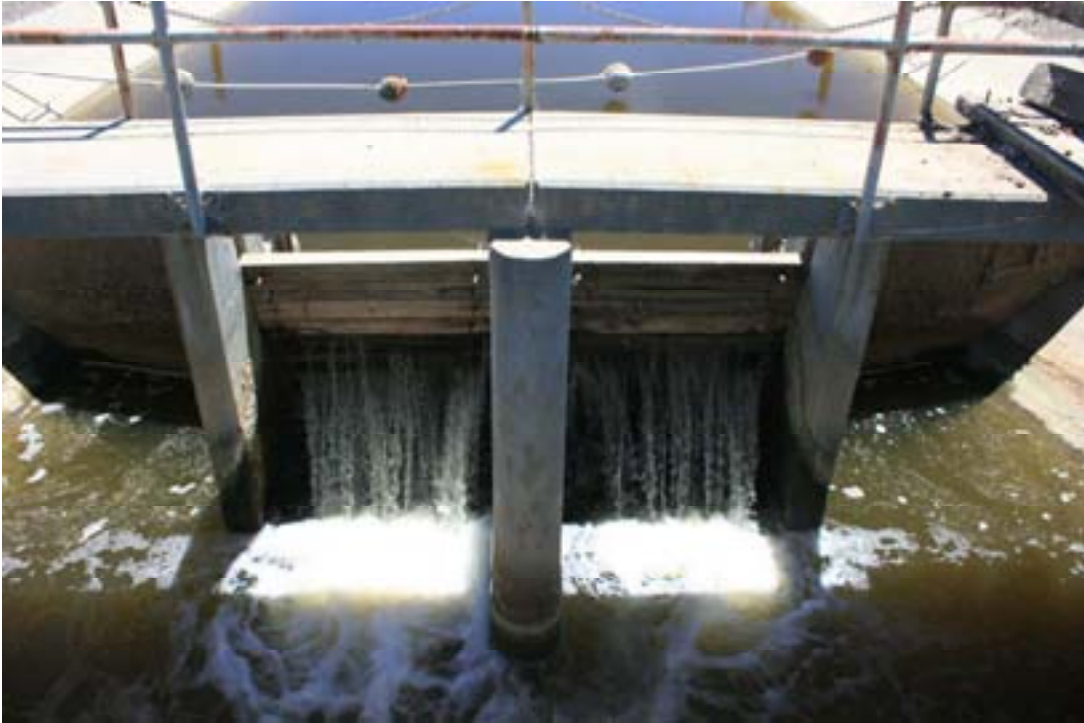
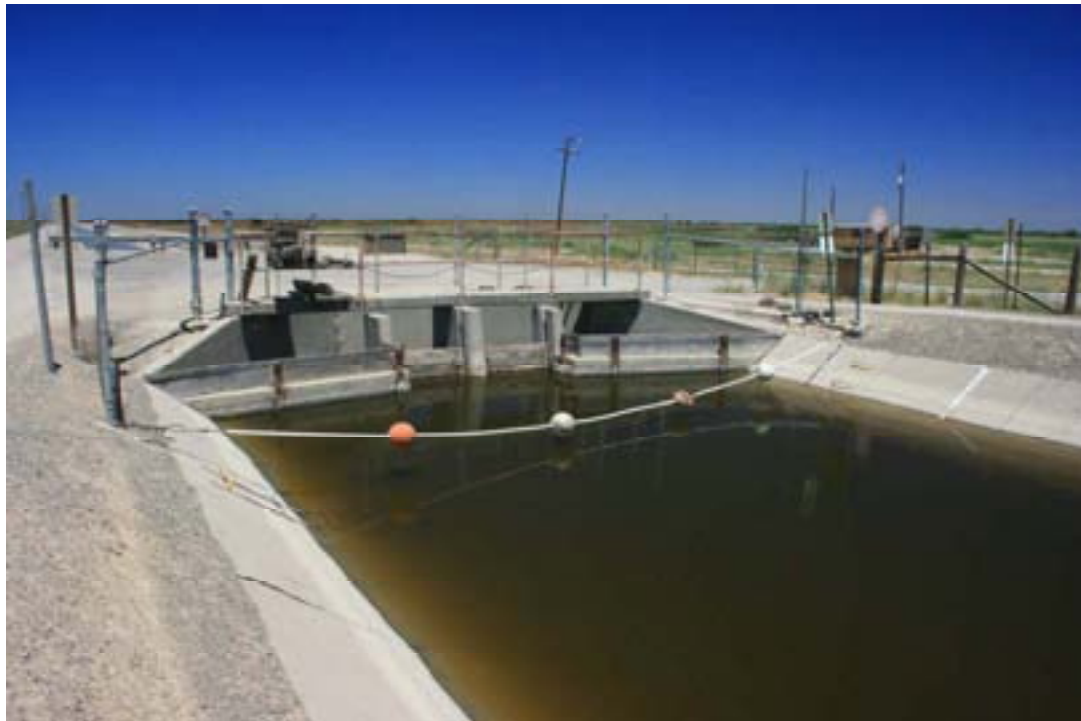
**Figure 15: Check Station 1 had leaky boards, sonde profile was performed from wall near boards.**

**Figure 16: Chlorophyll fluorescence as a function of depth for SLD Check 1.**
